BOIGU

UNDERSTANDING CLIMATE CHANGE DRIVEN COASTAL EROSION AND INUNDATION IMPACTS ON TORRES STRAIT COMMUNITIES AND THE DEVELOPMENT OF ADAPTATION OPTIONS

K.E. Parnell, S.G. Smithers and L. Ischenko
School of Earth and Environmental Sciences
James Cook University
Townsville

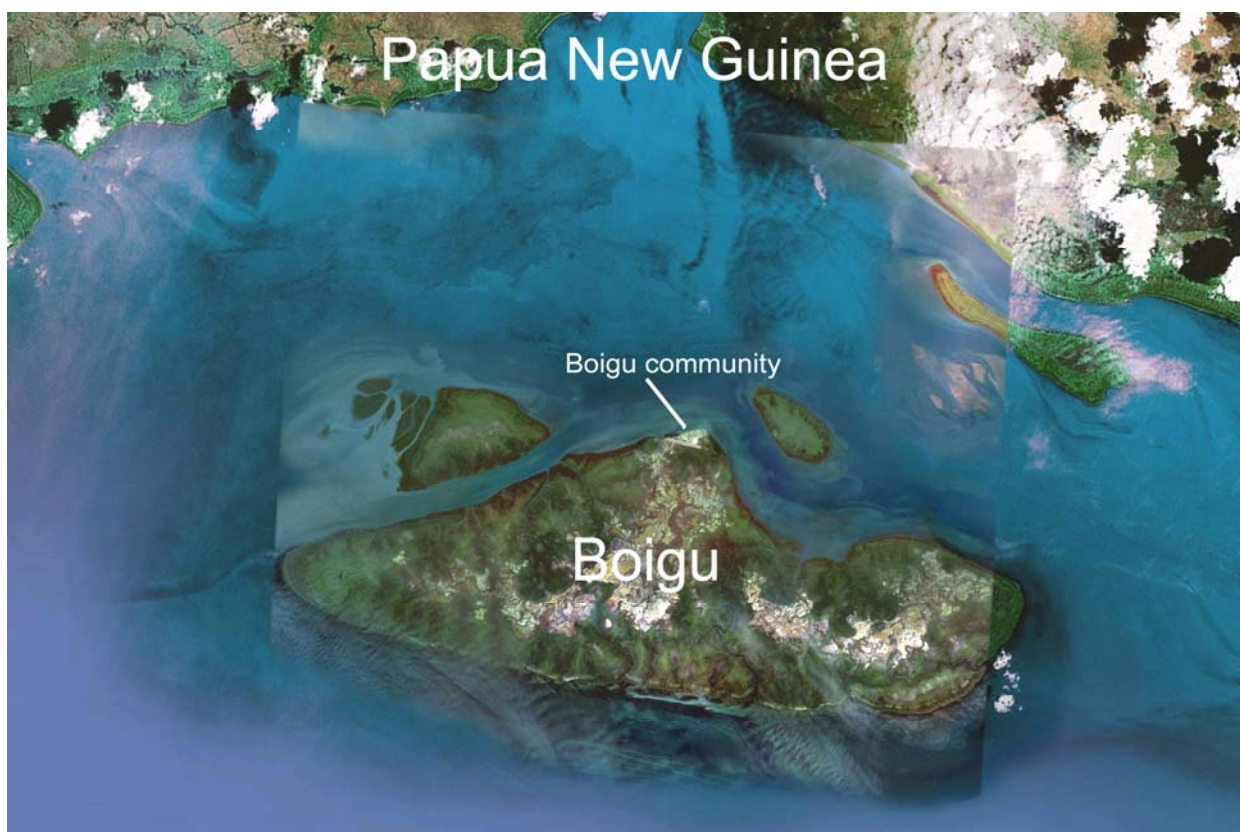
Figure 2.1: Boigu community faces north, and is protected from the southeast winds, and to some degree from the north winds by the Papua New Guinea mainland and relatively shallow water.

Boigu is a community of approximately 290 people (based on the 2006 census) (SLUP, 2010) approximately 8 km from the Papua New Guinea mainland (Figure 2.1). Boigu Island is a flat mud island, approximately 17km long by 6km wide. The village (Figure 2.2) is located on the northern shore. Boigu has been formed by an accumulation of mud and silt deposited on old coral platforms.

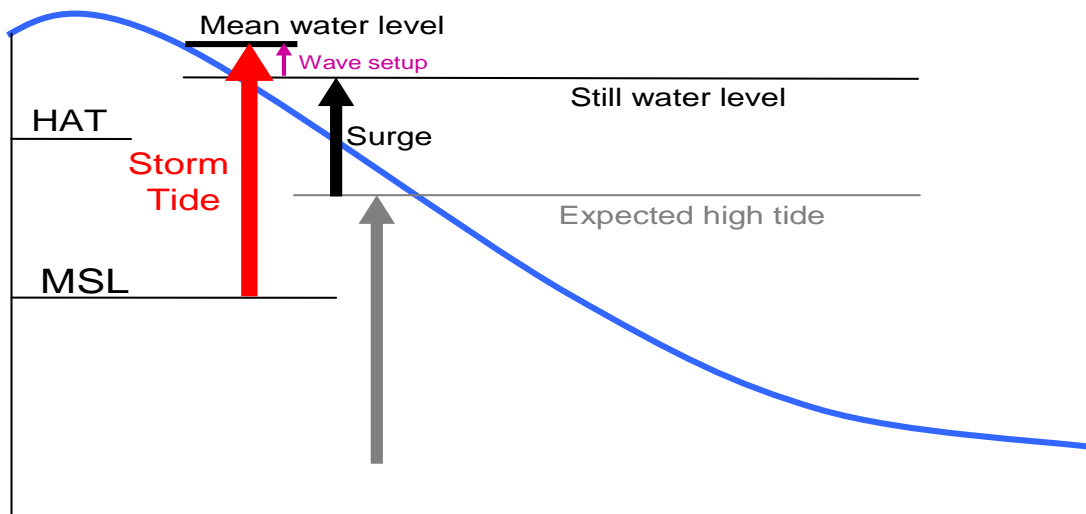
Figure 5.2: Definition diagram for inundation mapping.

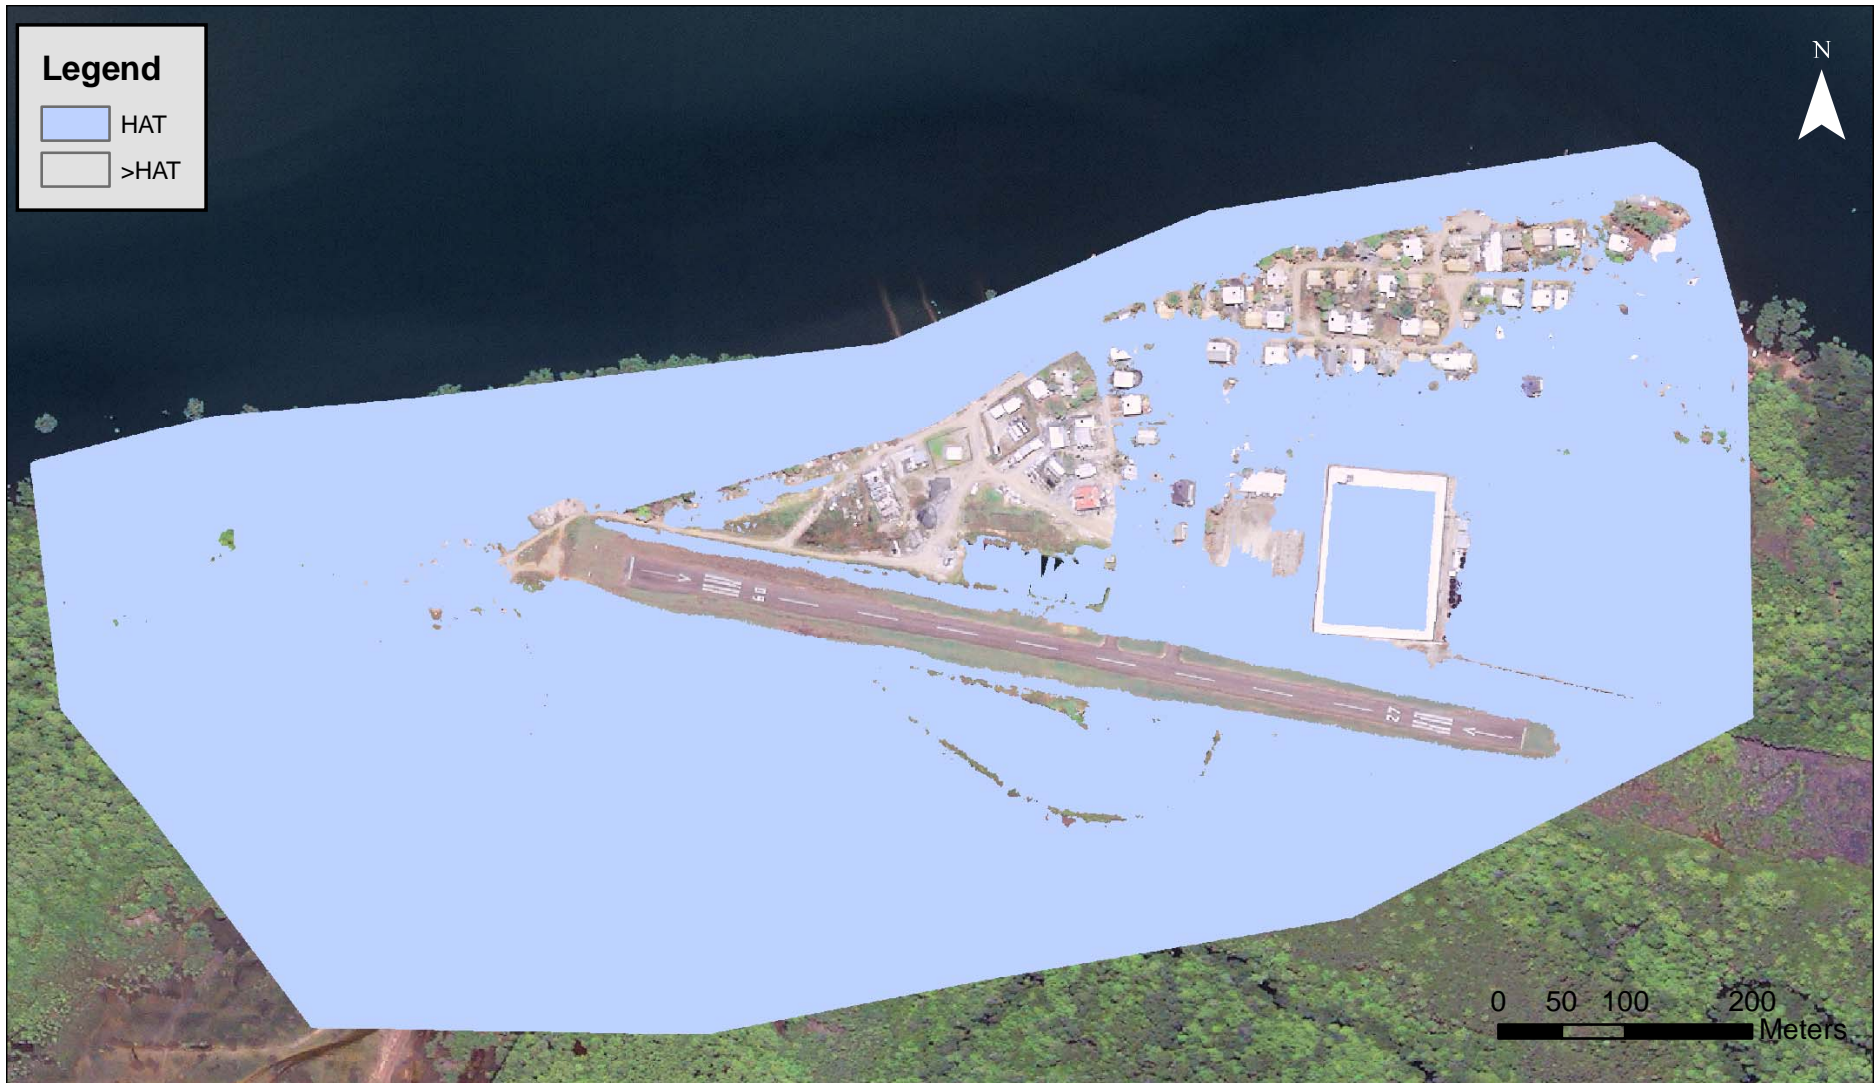
Figure 5.3a: Inundation at HAT (Highest Astronomical Tide).

The data we have shows that at highest astronomical tide (and this tide only happens very occasionally) much of the community at ground level is inundated (Figure 5.3a). With sea level rise of only 0.3m, more of the community is inundated, including

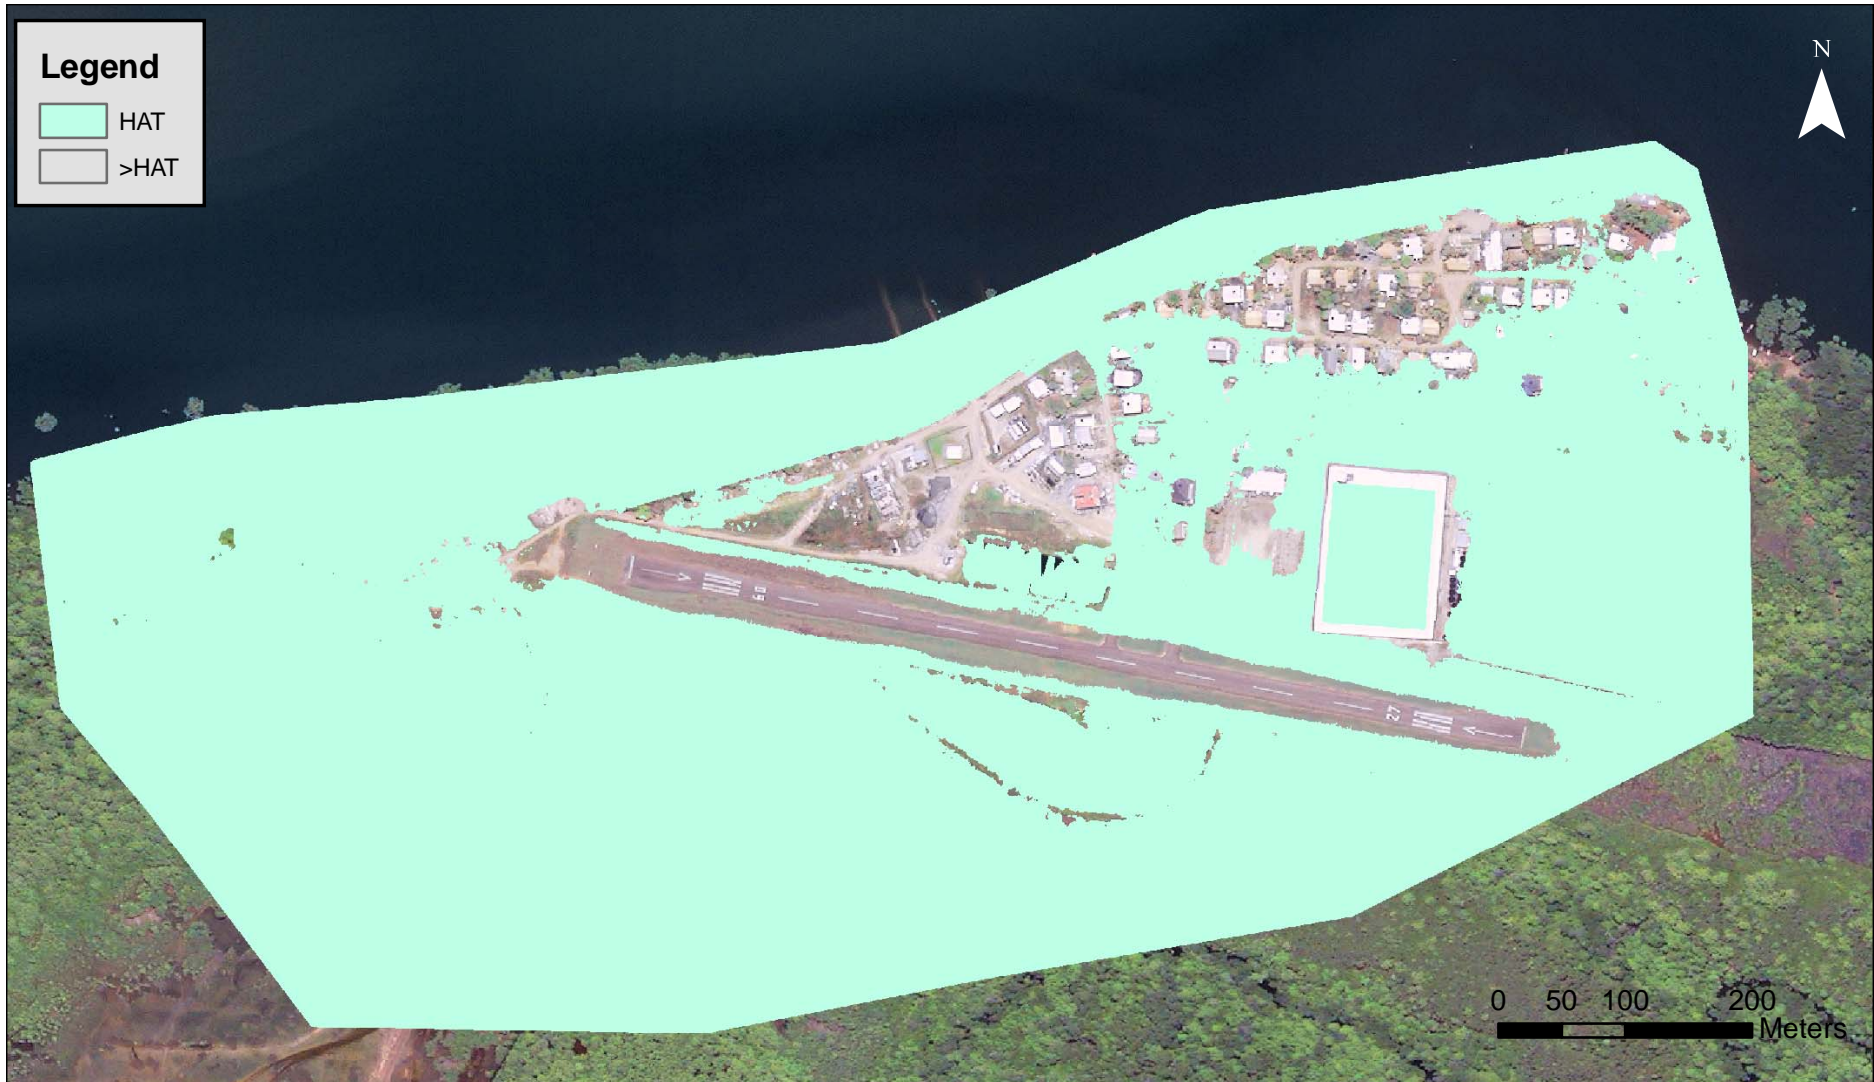
Figure 5.4a: Inundation at HAT (Highest Astronomical Tide).

importantly, the water facility. With 0.8m sea level rise and above, almost everything is underwater with the exception of the power station. Figure 5.4 looks at the situation with respect to storm tides. The 100 year storm tide is only a little higher than HAT for reasons discussed above. Figure 5.5 looks at the 1000 year return period storm tide. Even without sea level rise, the water facility is inundated with this event. Clearly, the issue of inundation is very serious for Boigu, and this is very well known in the community.

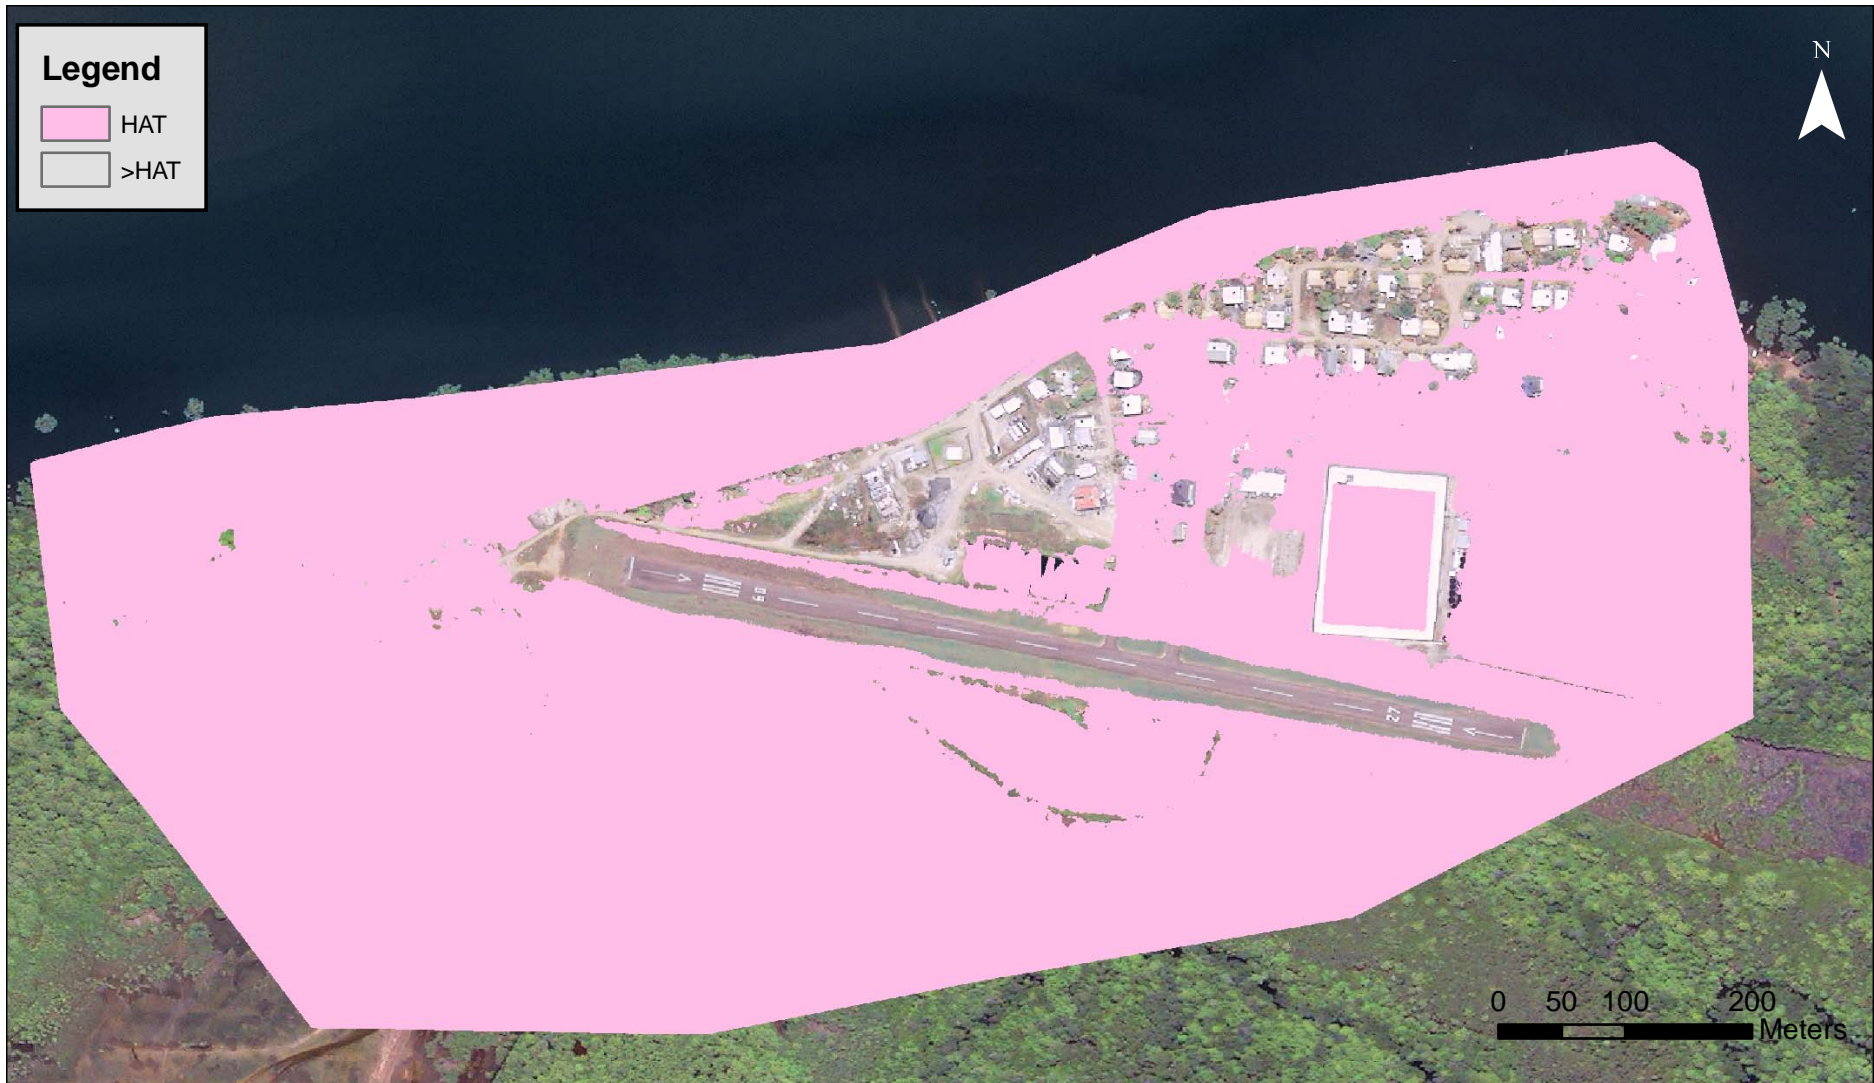
Figure 5.5a: Inundation at HAT.

The various different combinations of circumstances, plotted as 'bathtub' models, are shown in Figures 5.3 to 5.5. Each figure starts with the present day situation at the highest of the high tides (HAT), and then adds sea level rise only (Figure 5.3), the 100 year return period Storm Tide and sea-level rise (Figure 5.4), and the 1000 year return period Storm Tide and sea-level rise (Figure 5.5). These figures are plotted over the 2007 satellite image.

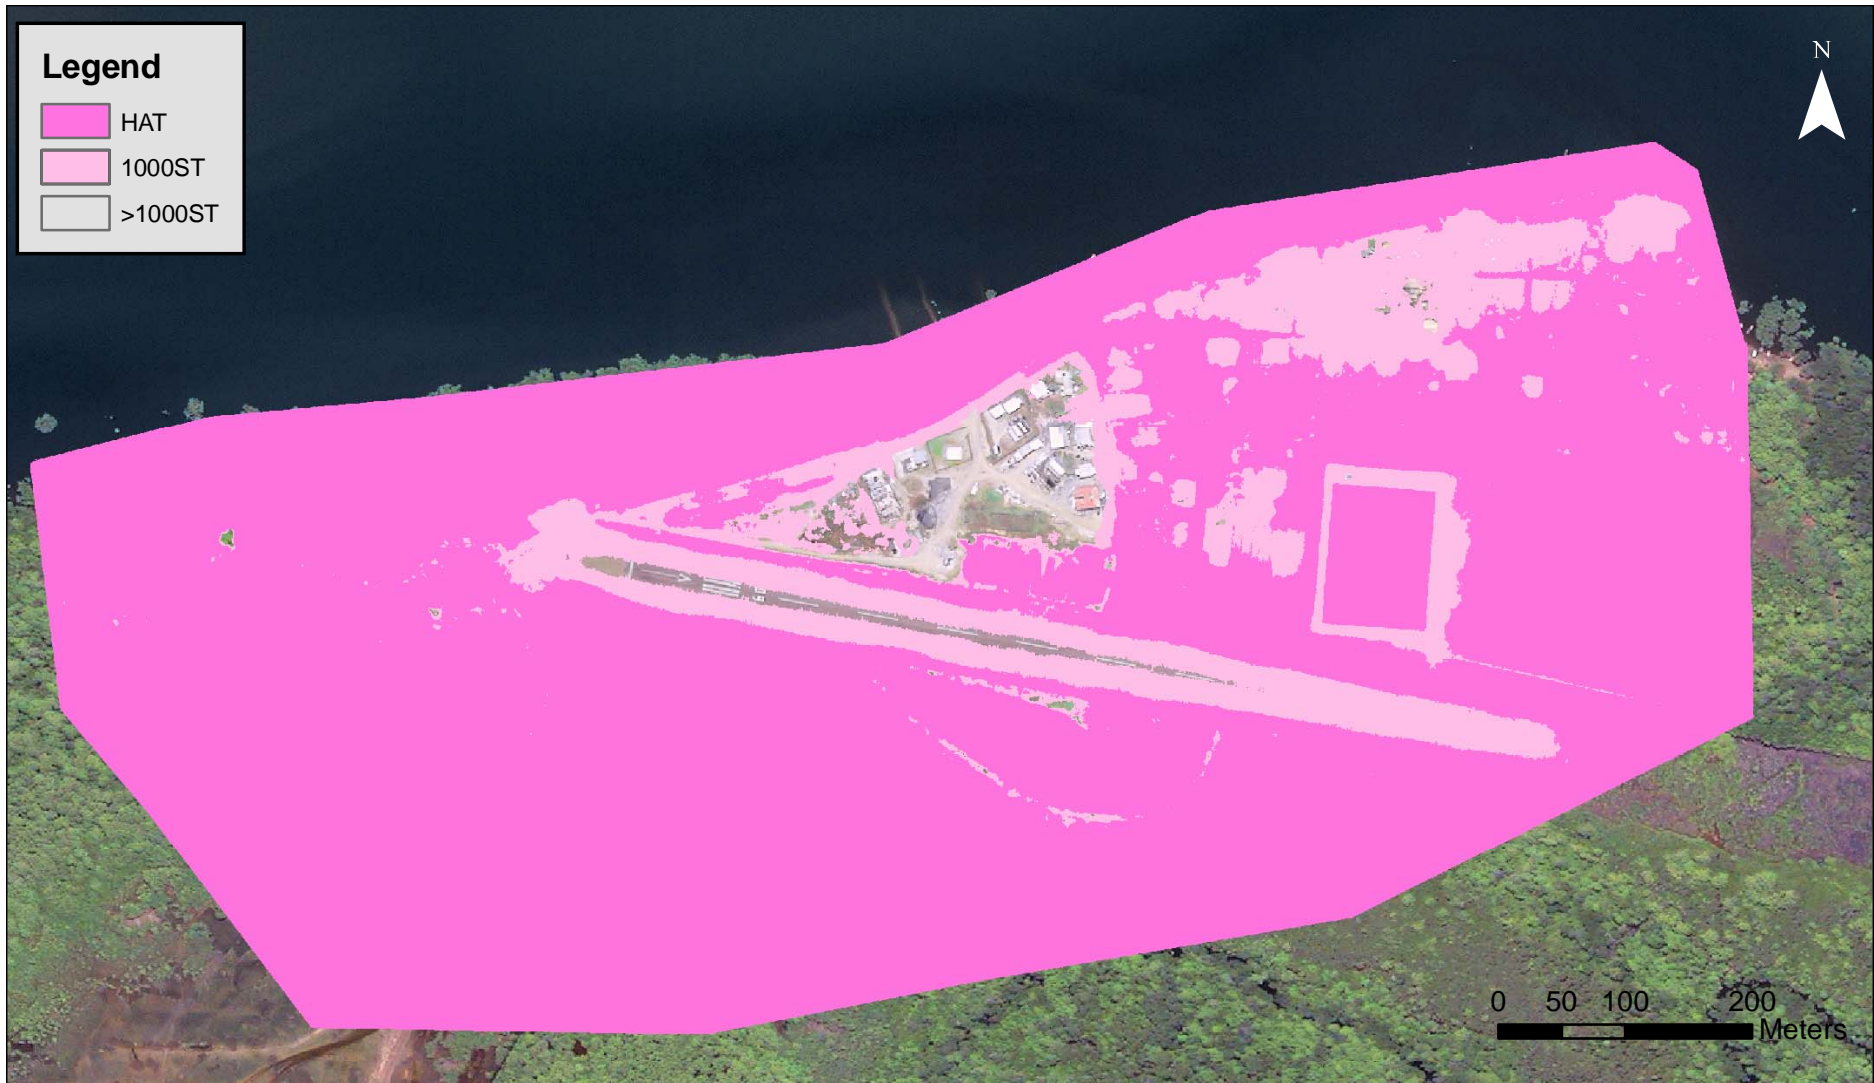
Figure 5.5b: Inundation at HAT with 1000 year return period Storm Tide.

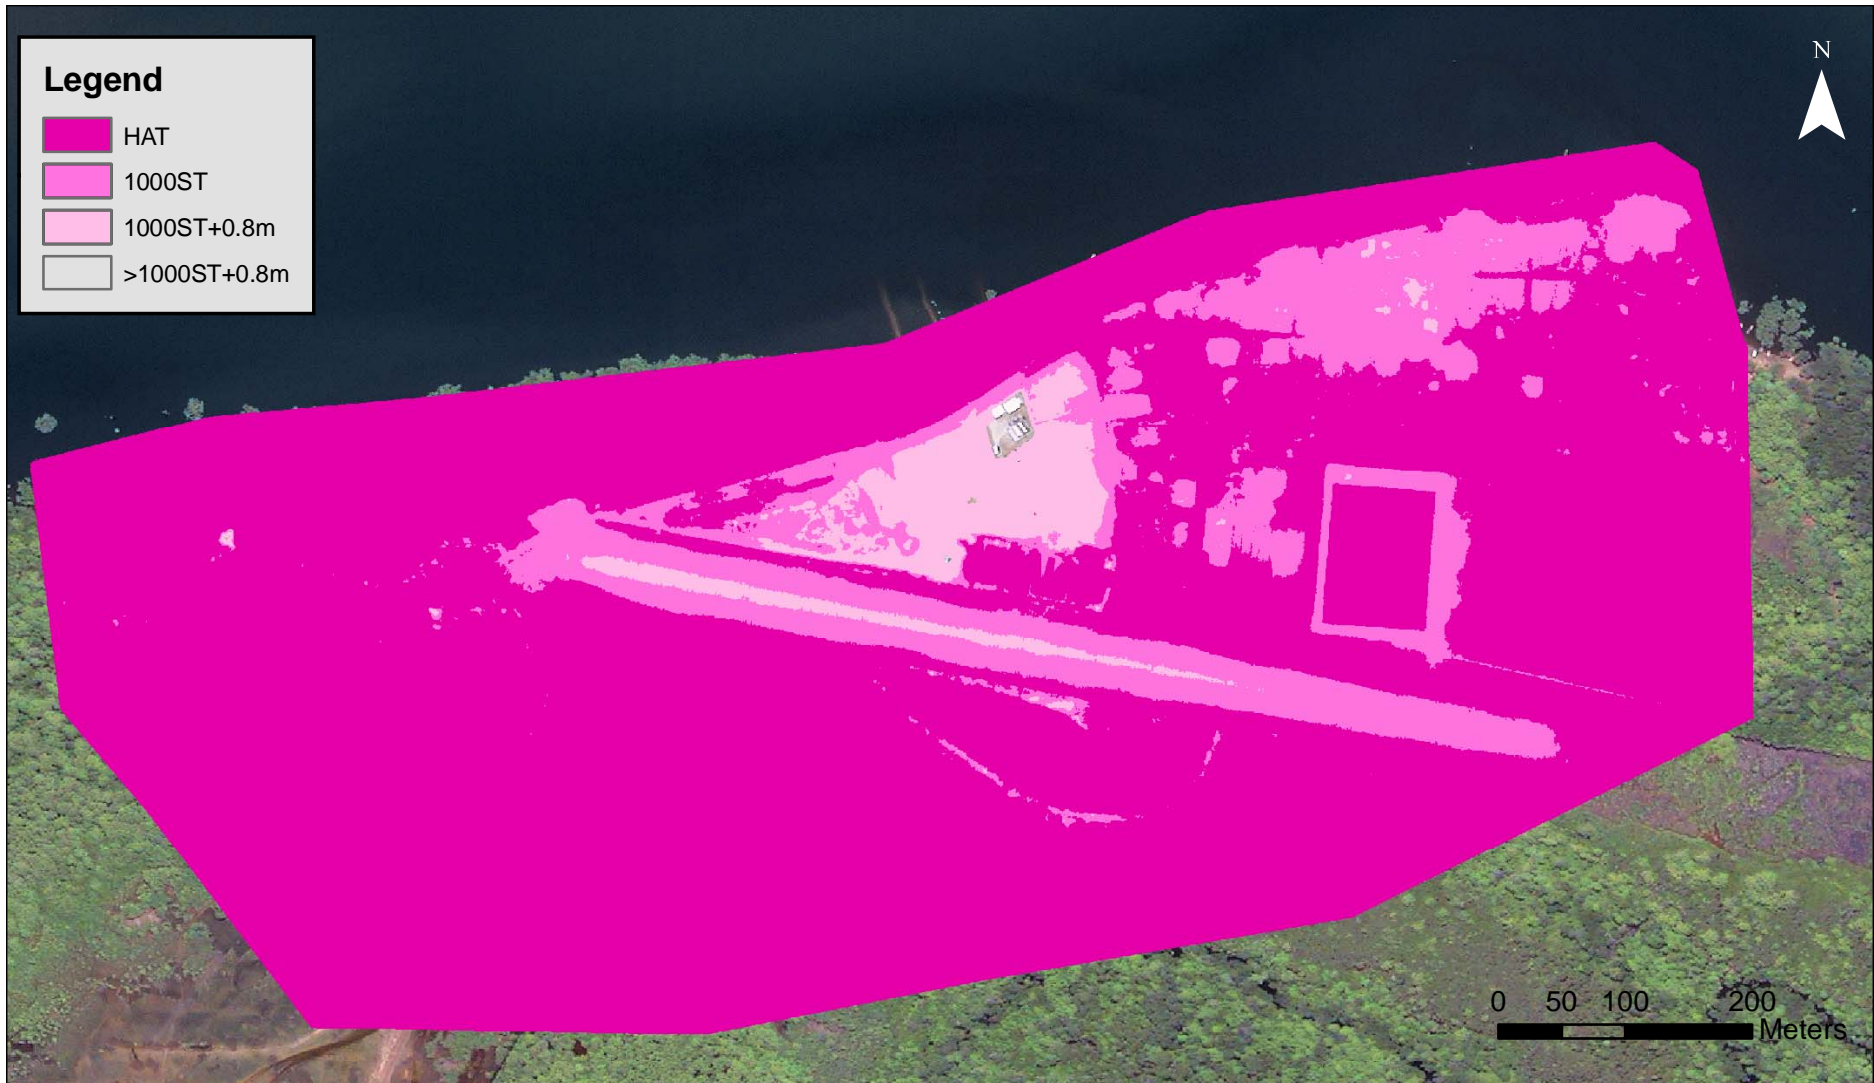
Figure 5.5c: Inundation at HAT with 1000 year return period Storm Tide and 0.8m sea level rise.

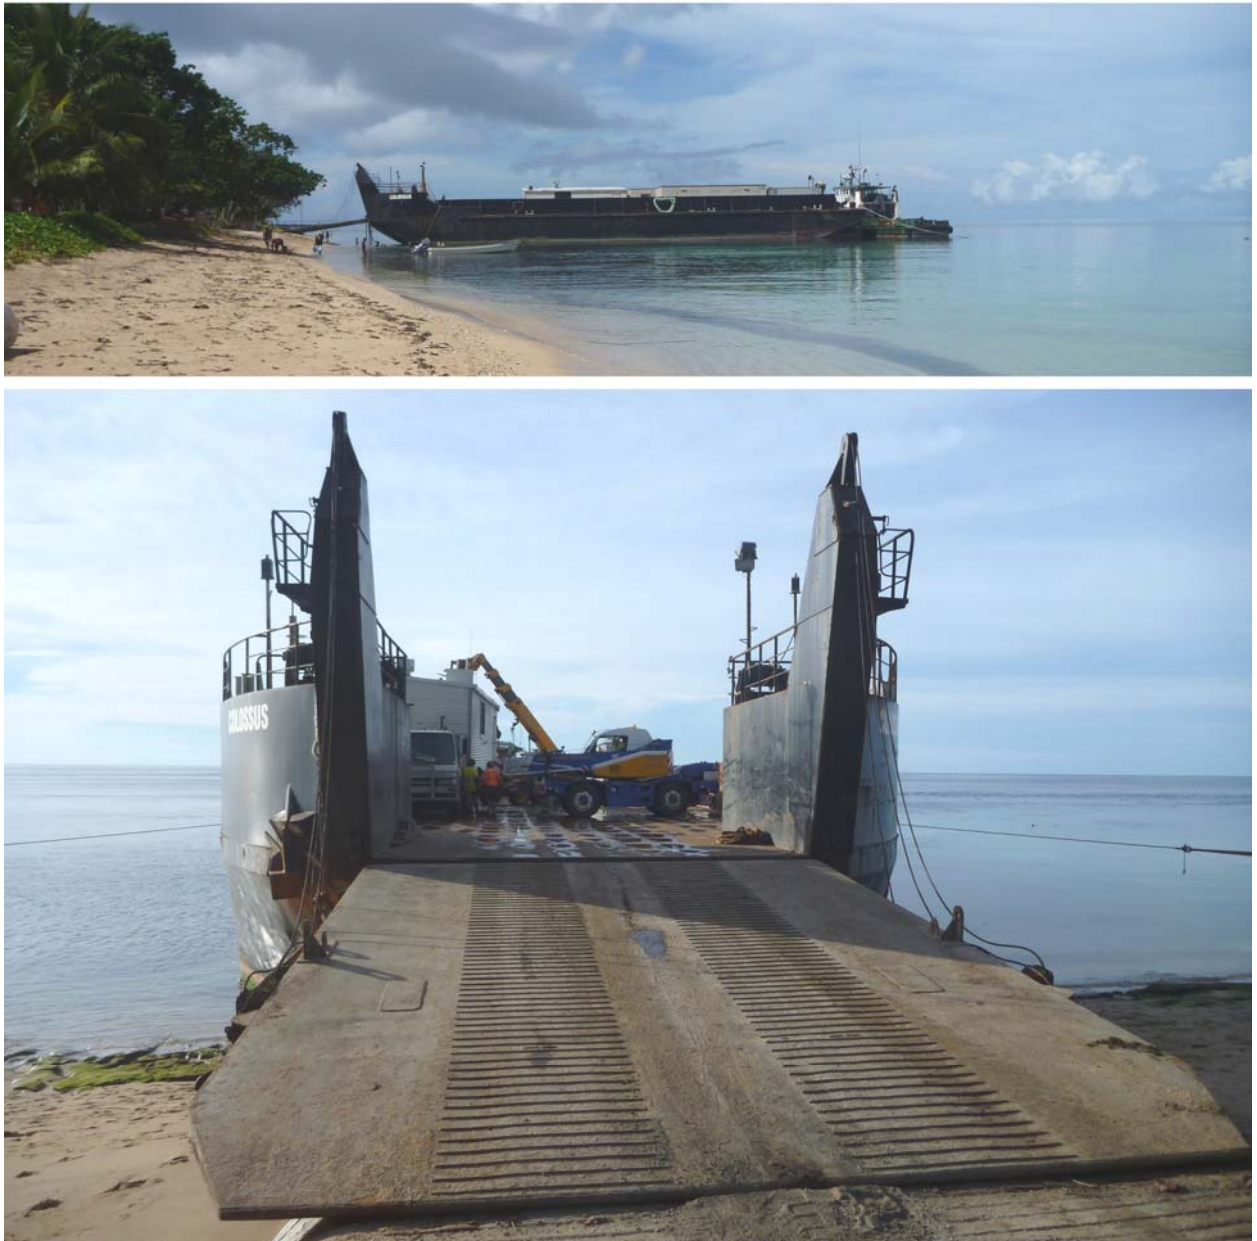
Figure 7.1: The Colossus, with a capacity of 1500 tonnes.

Black & More have provided an Opinion of Probable Cost to provide fill material from Cairns. This is based on transport using the “Colossus” barge (Figure 7.1). The cost estimate is \$140 per tonne, or \$380 per m³. This is based on an uncompacted volume. Clearly, the cost would be much reduced if a local source of fill material could be found. However, the experience in the area is that local material is generally difficult to get. A recent example is the need to get material from Cairns for ground works at the new school on Mer.

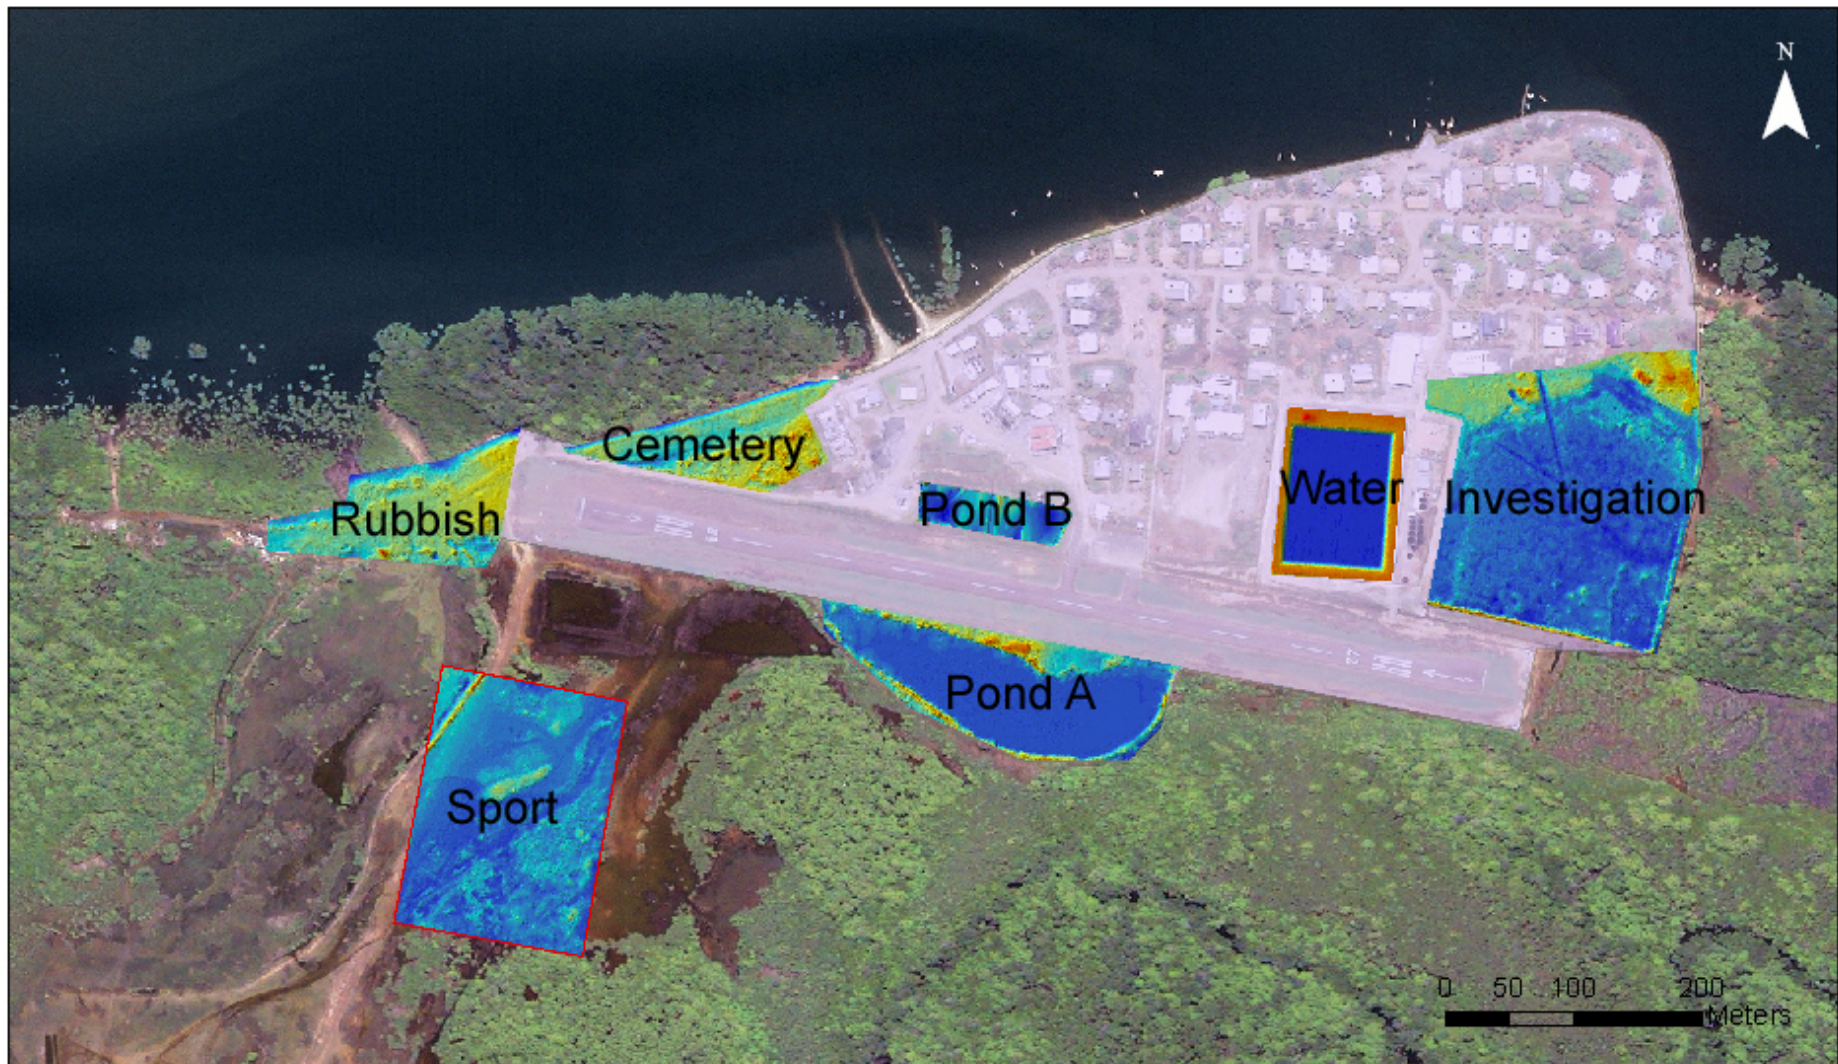
Figure 7.2: The area over which calculations of fill volume are made, and names used in the description.

In order to determine the approximate cost of elevating the community to various levels to provide protection, TIN models were used to estimate the volume below various surface levels. The same levels were applied as were used for the inundation analysis in Section 5. . The TIN model in Figure 5.1 was used as a base, and various smaller areas identified that could be considered separately. Figures 7.2 and 7.3 should be referred to in this analysis.

Table 7.1: The volume of fill material (m³) required to elevate areas to different levels. The definitions of areas are given in Figures 7.2 and 7.3.

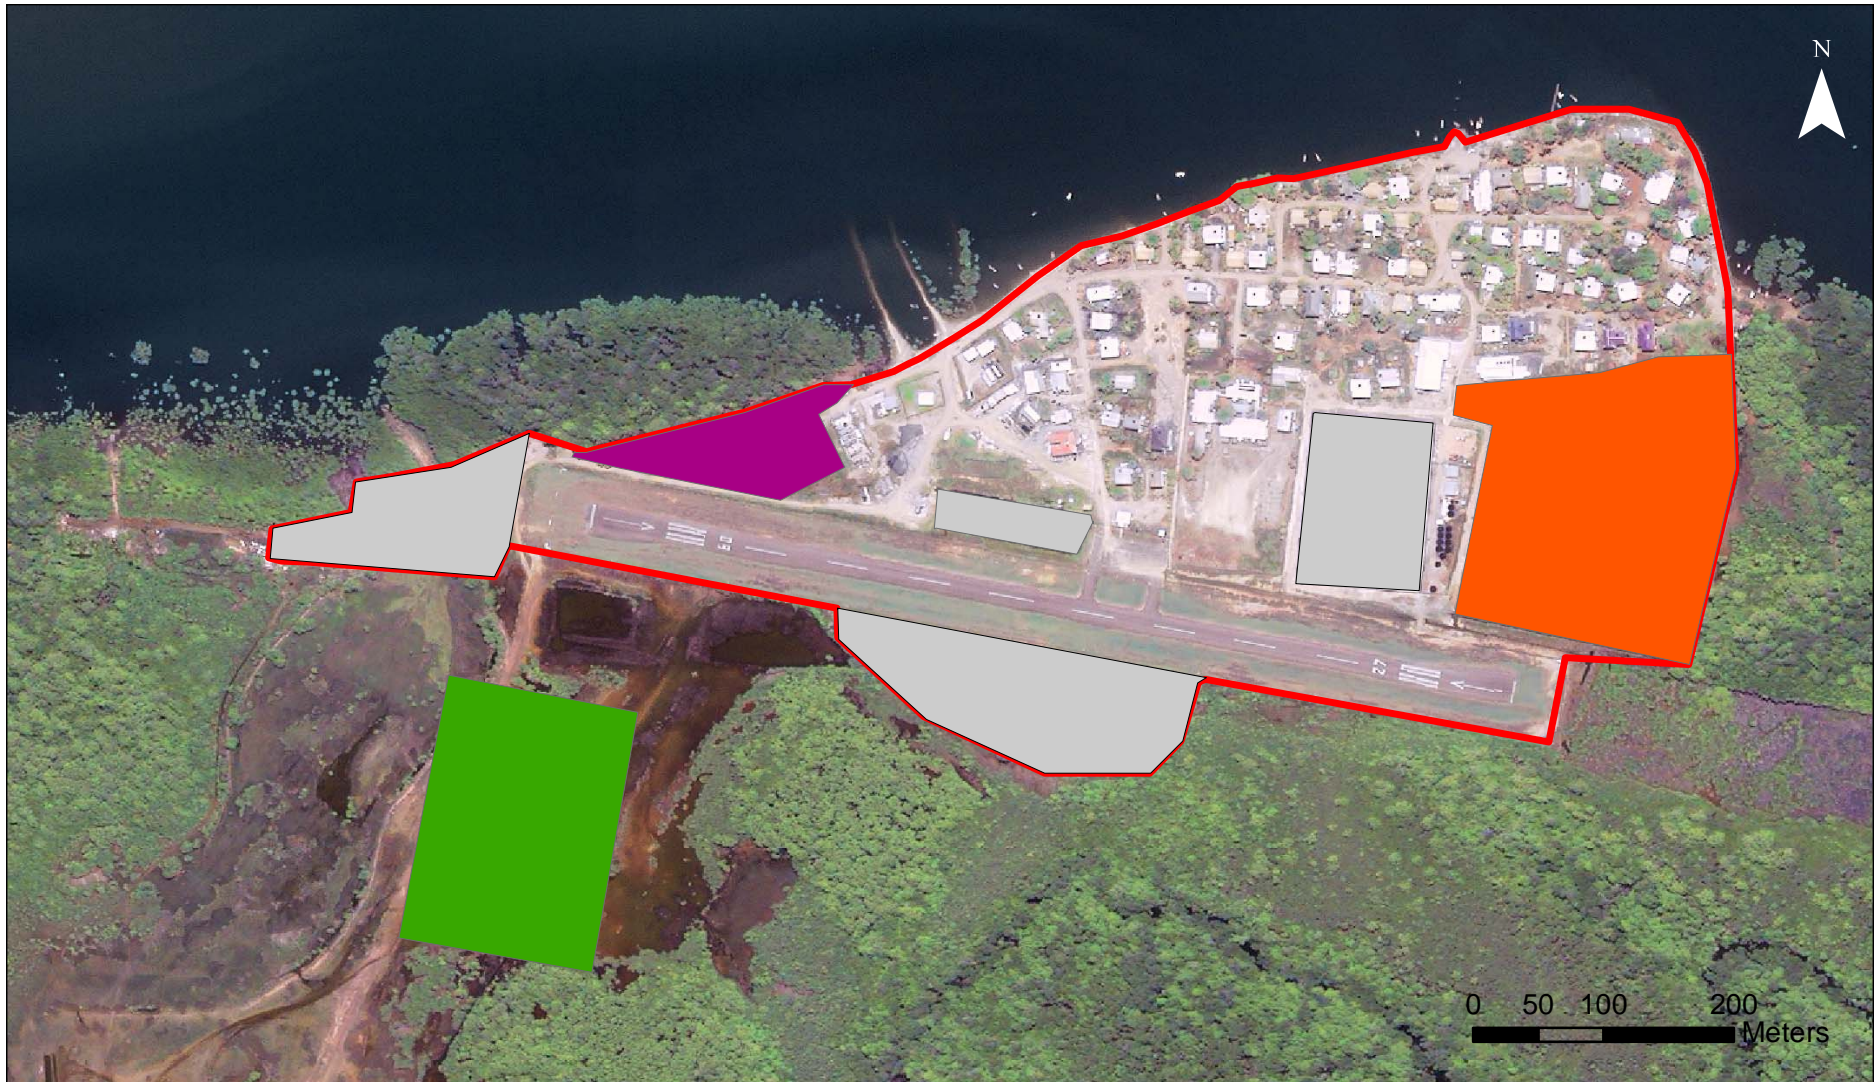
Figure 7.3: Areas which are included and excluded from the analyses. The areas highlighted in grey (the interior of the water facility, the ponds and the rubbish tip) are excluded for the purposes of calculating volume. The cemetery (purple), the investigation area (orange) and the sports area (green) are provided as separate estimates. In summary, “The Community” for which volume and cost is calculated (Tables 7.1 and 7.2) is the area highlighted in red, excluding all the shaded areas.
